**CWA COMPLIANCE EVALUATION INSPECTION REPORT**  
**U.S. ENVIRONMENTAL PROTECTION AGENCY, REGION 5**

Compliance Evaluation Sampling Inspection

FOIA EX 6 [REDACTED] Pork, Inc  
Rural Route 1 Box 158  
Sigel, IL 62462  
Shelby County  
38.243N, 88.482W

April 3, 2014

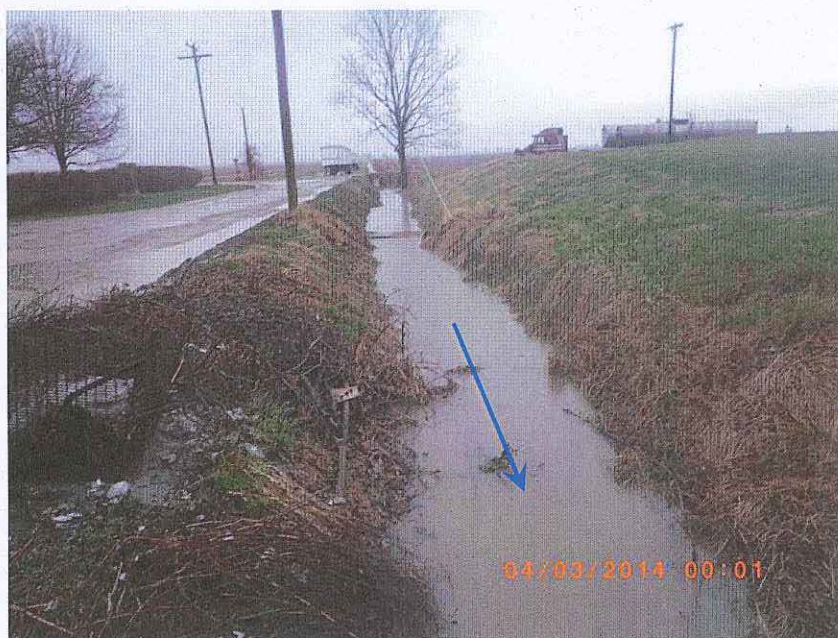
1: IMGP0003

Description: Looking upstream at the roadside ditch which flows from the north. Blue arrows indicate flow direction in this and subsequent photos.

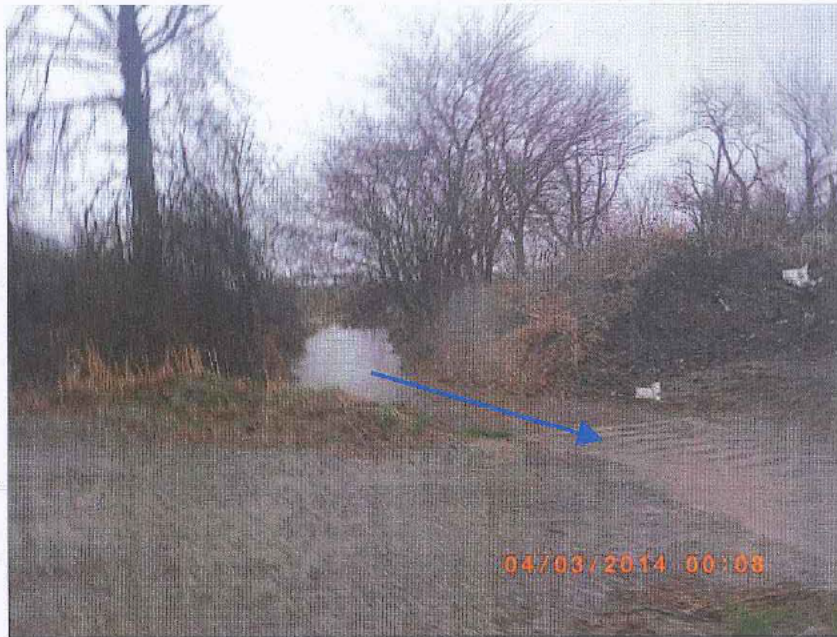
2: IMGP0004

Description: Looking upstream at the perennial tributary that flows from the north on the east side of the Nursery Barn.

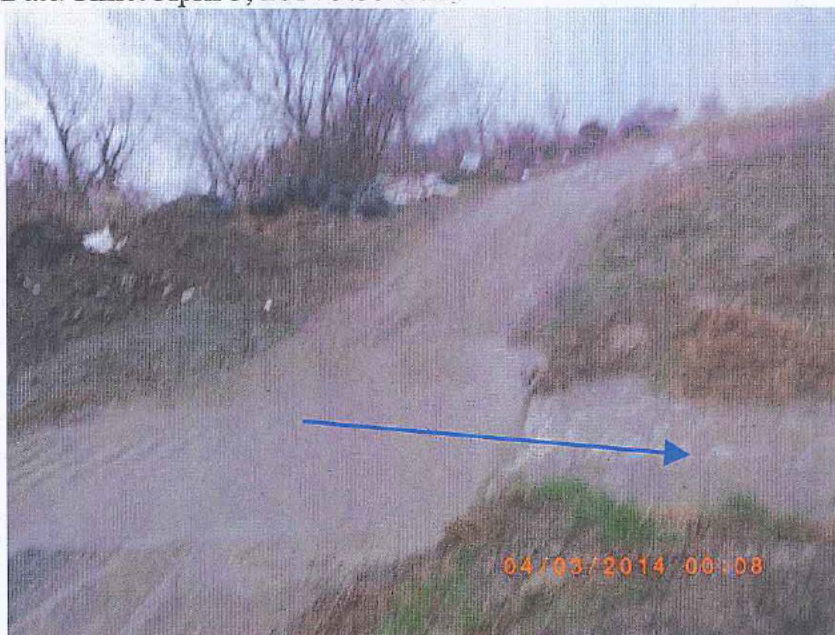
3: IMGP0005

Description: The perennial tributary typically flows through a culvert under the facility's access road. On the day of the inspection, the tributary was full and overtopped the road.

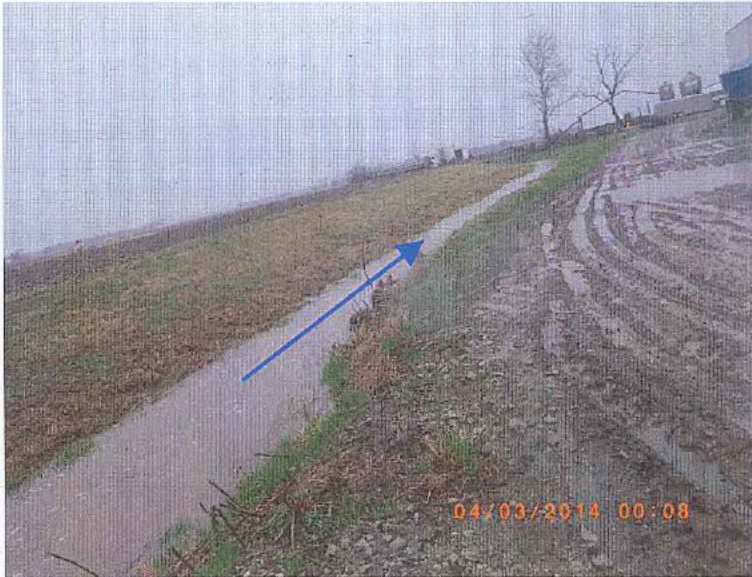
4: IMGP0006

Description: The perennial tributary flows to the west along the southern edge of the production area.

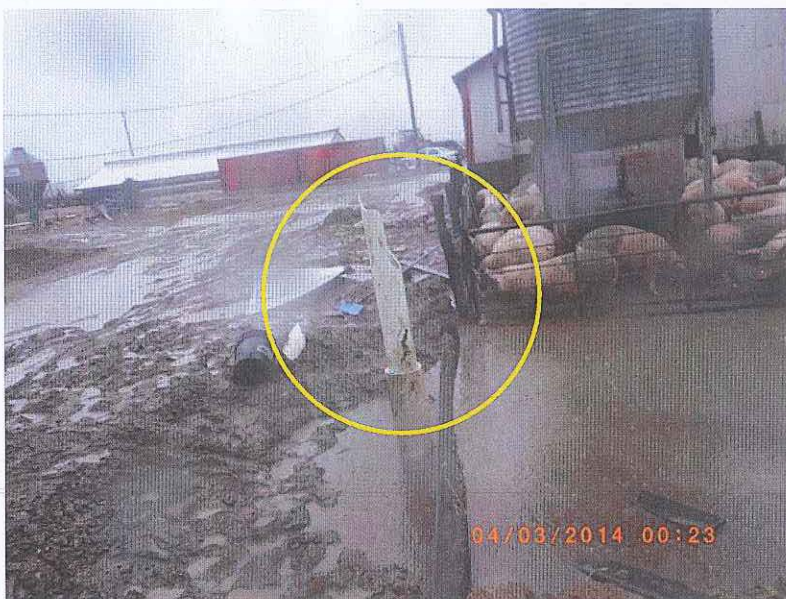
15: IMG0025

Description: At the southwest corner of the open pen of the West Barn is an inlet pipe (white pipe). When opened manually, the process wastewater flows into the pipe and to a reception pit on the east side of Barn #5.

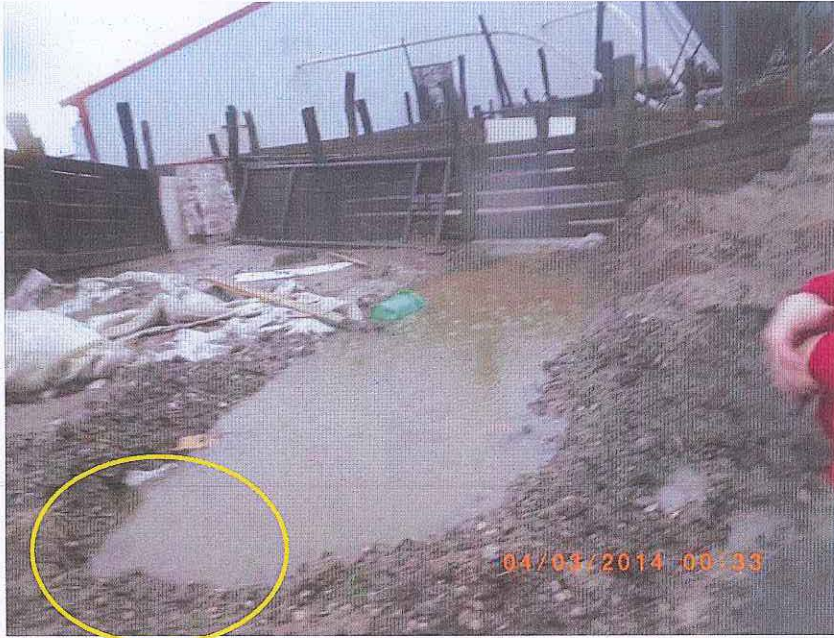
22: IMGP0036

Description: Pipe in this area has been capped and can no longer transport process wastewater from the receiving pen of Barn #2 to the perennial tributary. Yellow circle denotes location of inlet of pipe in receiving pen concrete channel.

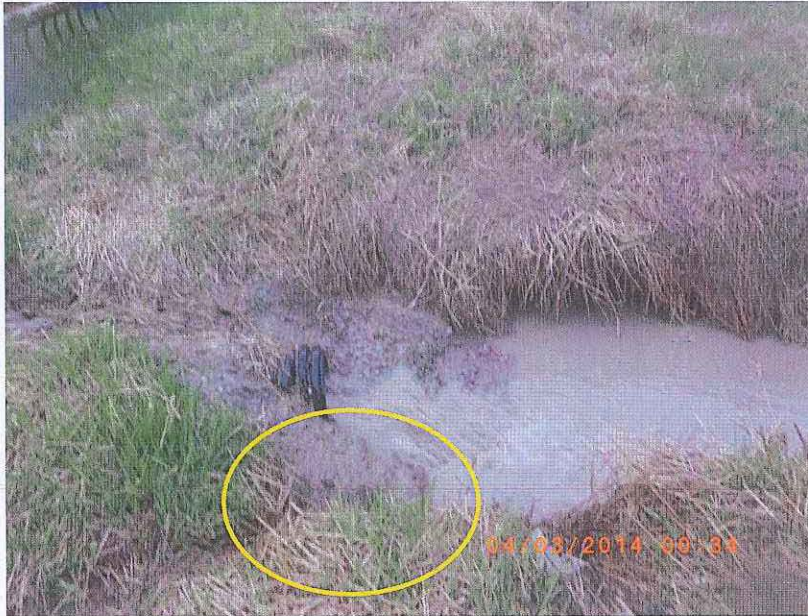
24: IMGP0038

EPA walked to the ditch that both the pipe from the receiving pen east of Barn #2 and the storm water pipe west of the West Barn outletted into. The ditch is approximately fifteen feet in length and flow in the ditch flowed directly to the perennial unnamed tributary. A pathway of overland flow from the production area also flowed into the ditch. EPA only observed one pipe, the black storm water pipe. The facility manager pointed out the the other pipe was encased in concrete and the outlet of the pipe could not be seen. The overland flow of storm water had eroded a channel under and around the concrete.

There was flow from the black storm water pipe into the ditch and the ditch and the perennial tributary contained water on the day of the inspection.

Description: The black pipe is the outlet of the storm water pipe that originated west of the West Barn. Yellow circle denotes location of the other pipe that outletted here, the one from the receiving pen of Barn #2. This pipe is encased in concrete now.

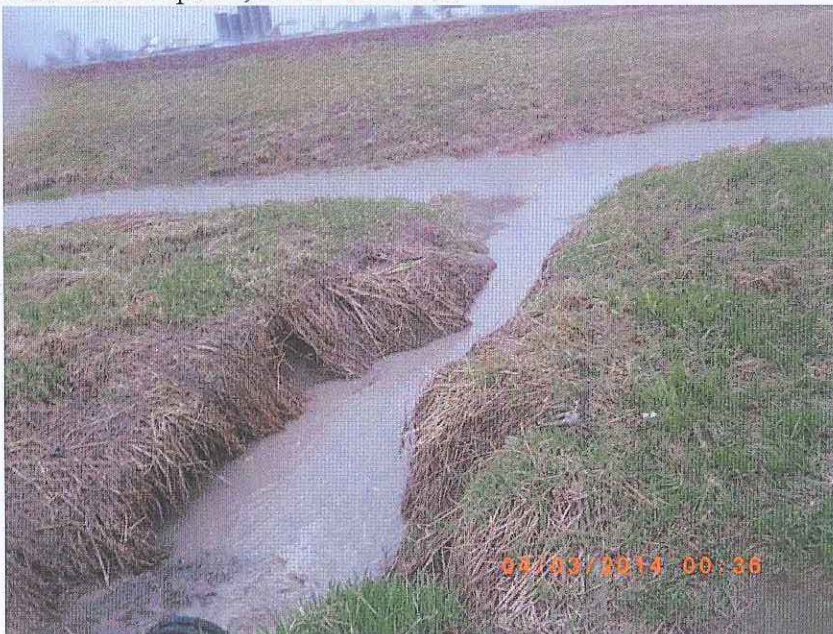
25: IMGP0040

Description: The black pipe outlets to a ditch which flows approximately 15 feet before it conflues with the perennial tributary.

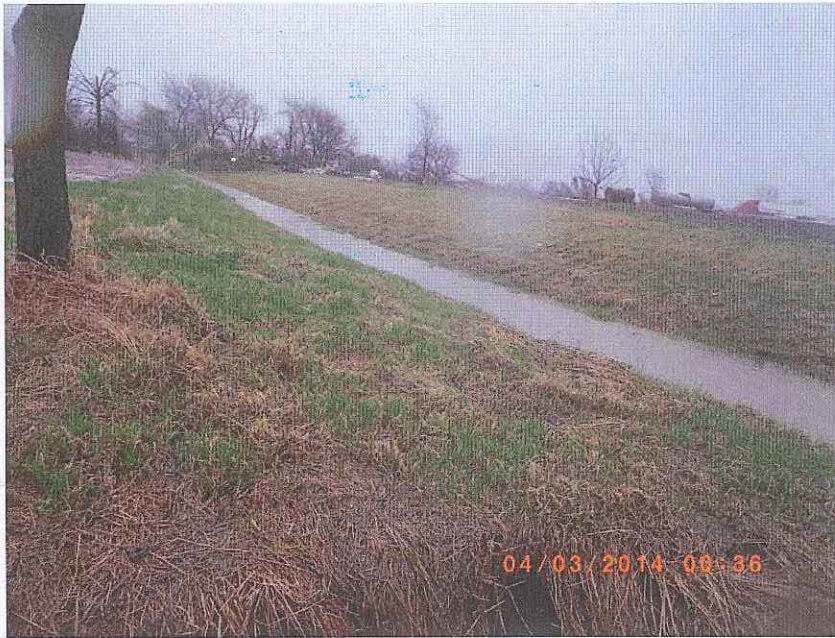
26: IMGP0041

Description: Looking upstream at the perennial tributary.

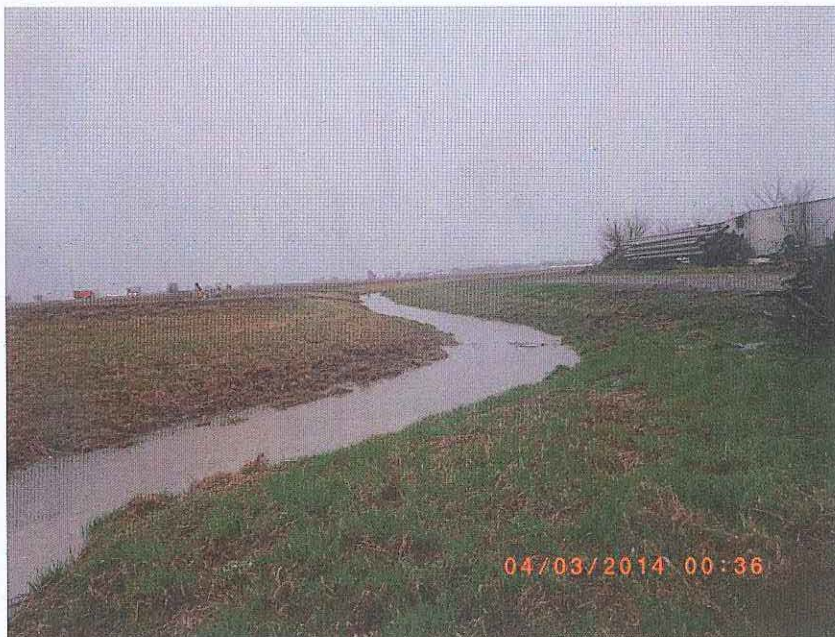
27: IMGP0043

Description: Looking downstream at the perennial tributary. Note bed and bank structures.

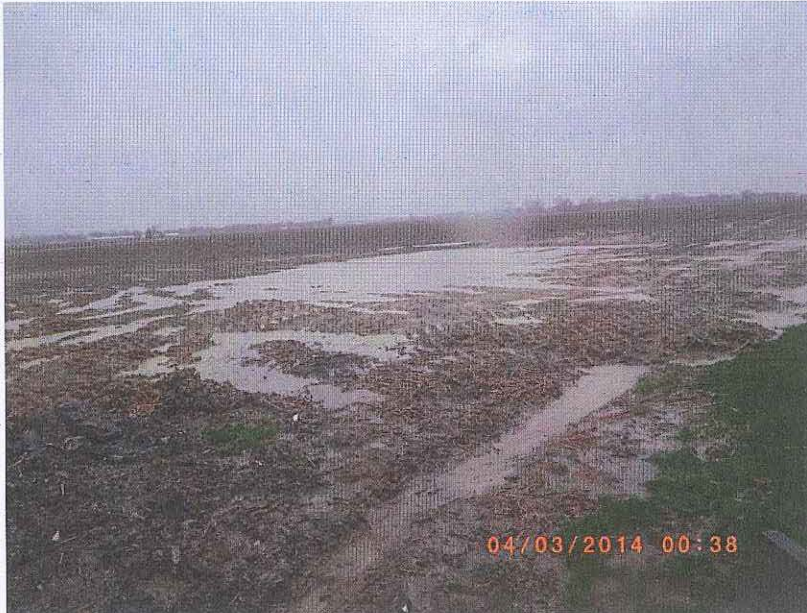
28: IMG0047

Description: Location of new Compost Barn which will be 60' long and 10' wide and contain 12 bays.

EPA walked to the west, south of Barn #1 where the facility owner intends to build a Compost Barn as a permanent measure to prevent leachate from the composting materials from reaching the unnamed tributary. The Compost Barn will be a covered 60' x 10' barn with 12 bays.

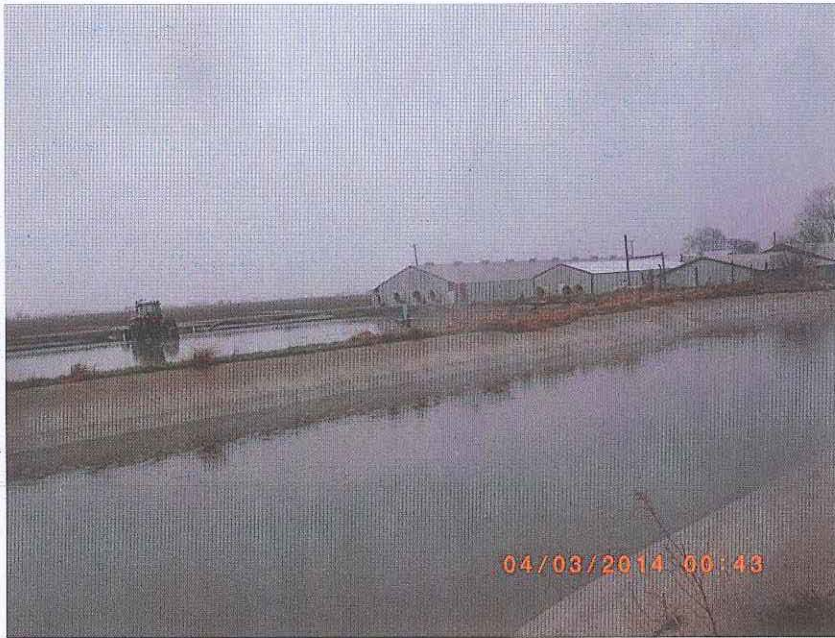
29: IMGP0050

EPA then walked to the west and observed the 1<sup>st</sup> and 2<sup>nd</sup> Stage Manure Ponds. There was no staff gauge in either pond, but a pump pipe with nails in it was used by facility personnel to measure the amount of freeboard. EPA and the facility manager observed over four feet of freeboard on the day of the inspection.

Description: 2<sup>nd</sup> Stage Manure Pond in the foreground has over four feet of freeboard.

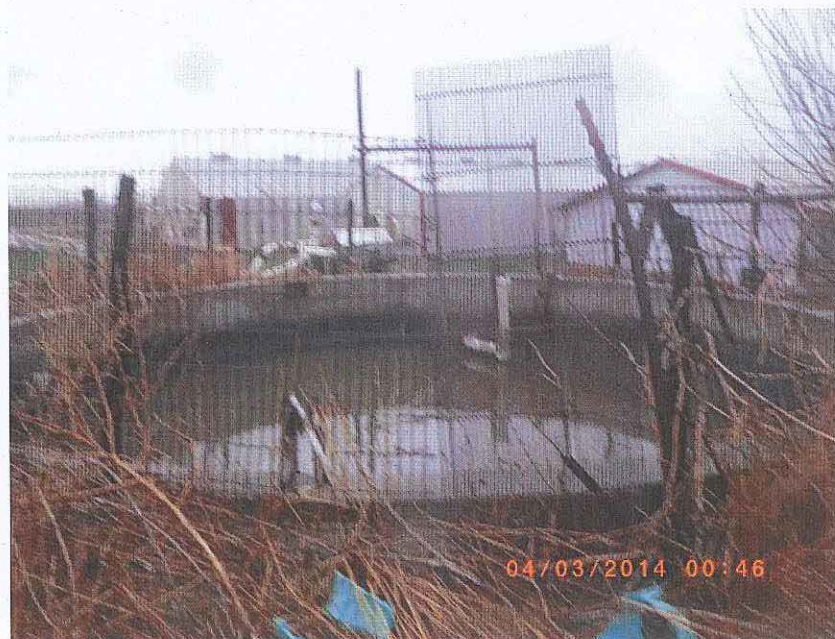
30: IMGP0053

Description: Circular Pit receives wastewater from 2<sup>nd</sup> Stage Manure Pond that will be used for flushing the barns.

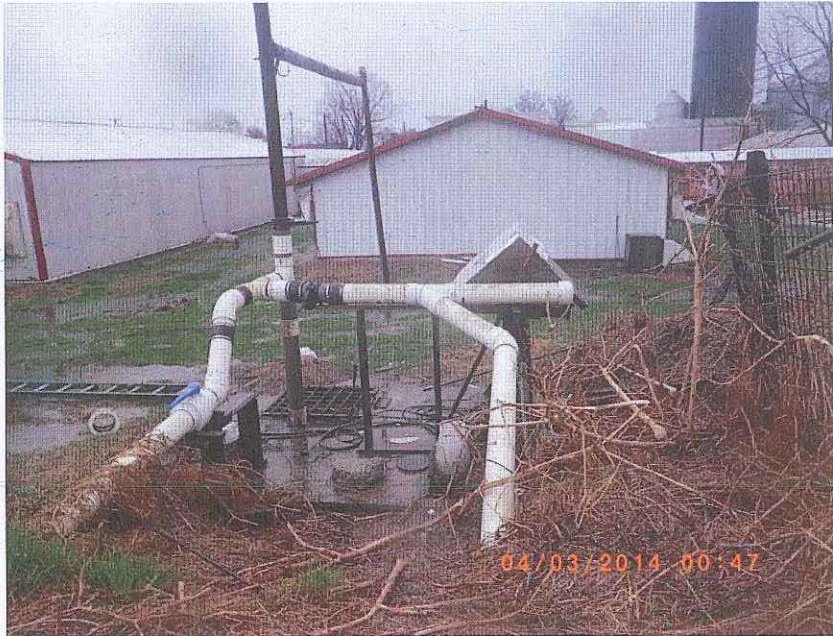
31: IMGP0054

Description: Reception pit for manure and process wastewater from the barns before it is pumped to the 1<sup>st</sup> Stage Manure Pond. Also note that storm water on the ground between the barns. The storm water flows into pipes which transport the storm water to the east side of the barns.

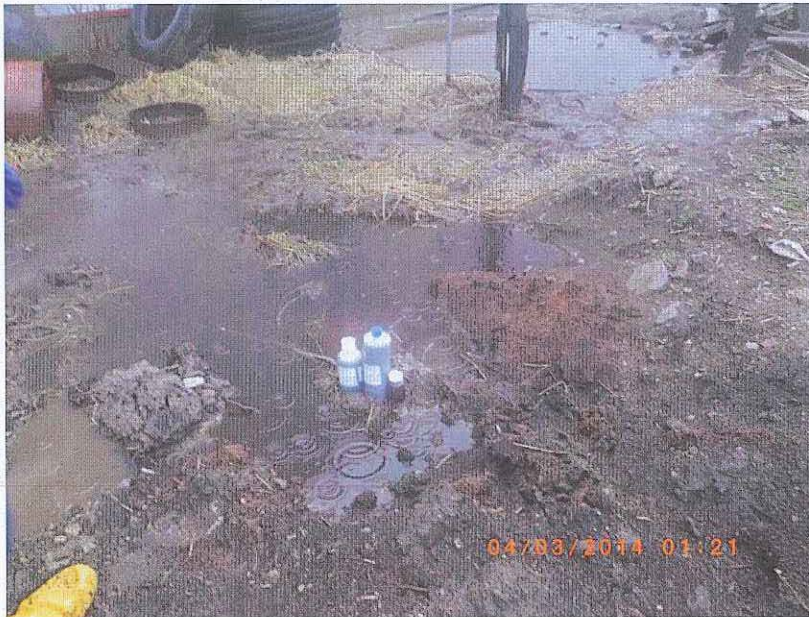
33: IMGP0056

EPA then followed the flow pathway from the Compost Pile to the southeast and then south to the perennial unnamed tributary. EPA noted the differently colored plume in the puddle and in the flow pathway from the Compost Pile. EPA documented that the flow from the Compost Pile followed along the ground and was unbroken and continuous all the way to the unnamed tributary. At the stream bank, a channel had been eroded through the bank from the flow of water.

Description: Sample S01, "Compost puddle" was taken at 10:46 A.M. from a puddle on the outside of the berm around the Compost Pile where the puddle appeared to contain leachate from the compost.

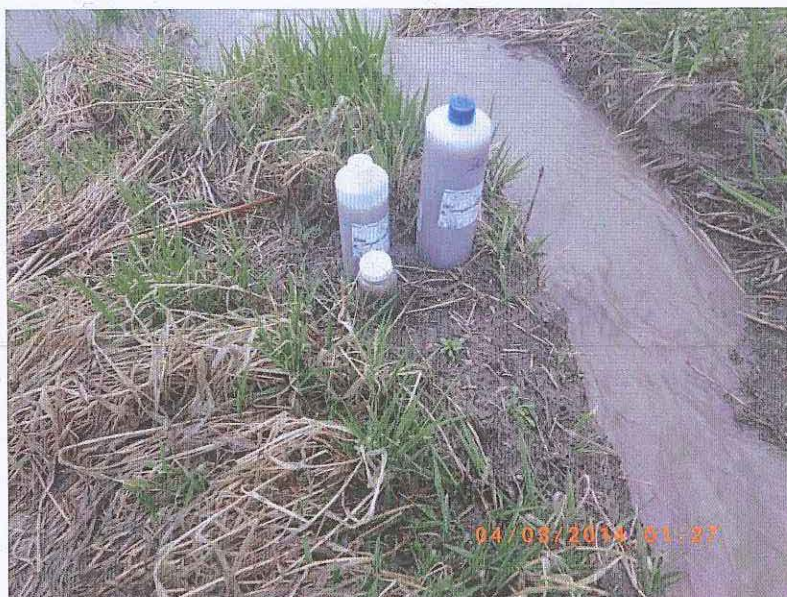
41: IMGP0070

EPA took sample number two, S02, named "Compost Stream, at 10:52 A.M. from the flow at the confluence of the pathway that began with the puddle at the Compost Pile and the unnamed tributary.

Description: Sample S02, "Compost Stream", was taken at 10:52 A.M. from the stream of storm water and process wastewater from the Compost Pile at the the confluence with the perennial tributary.

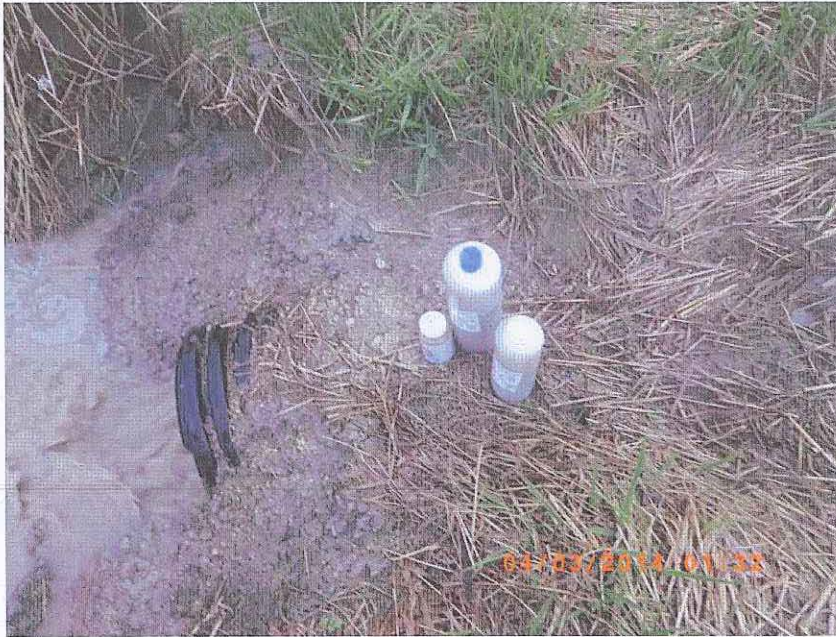
42: IMGP0077

Description: Sample S03, "Black Pipe", was taken at 10:57 A.M. from the flow coming out of the black pipe.

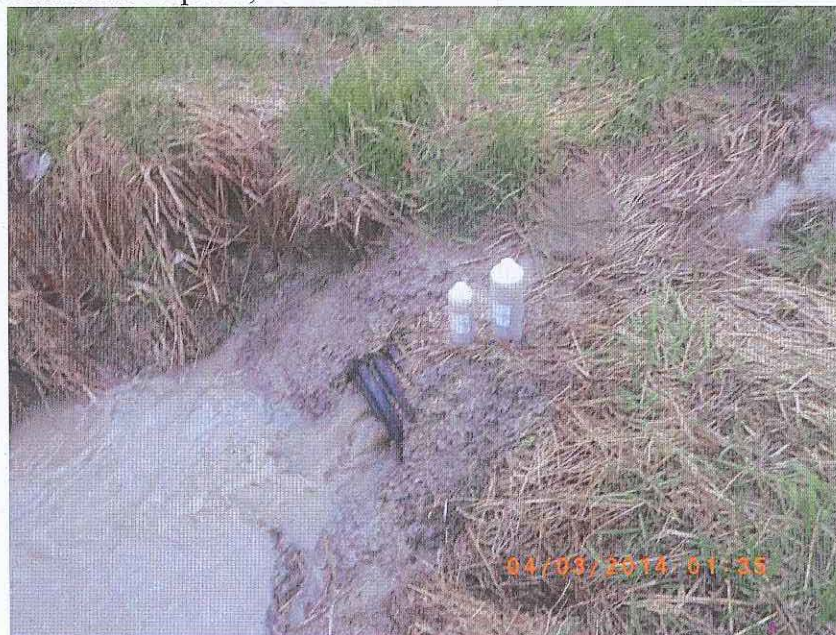
43: IMGP0078

Description: Sample S04, "Duplicate of Black Pipe", was taken at 11:00 A.M. from the flow coming out of the black pipe. No duplicate fecal coliform sample was taken.

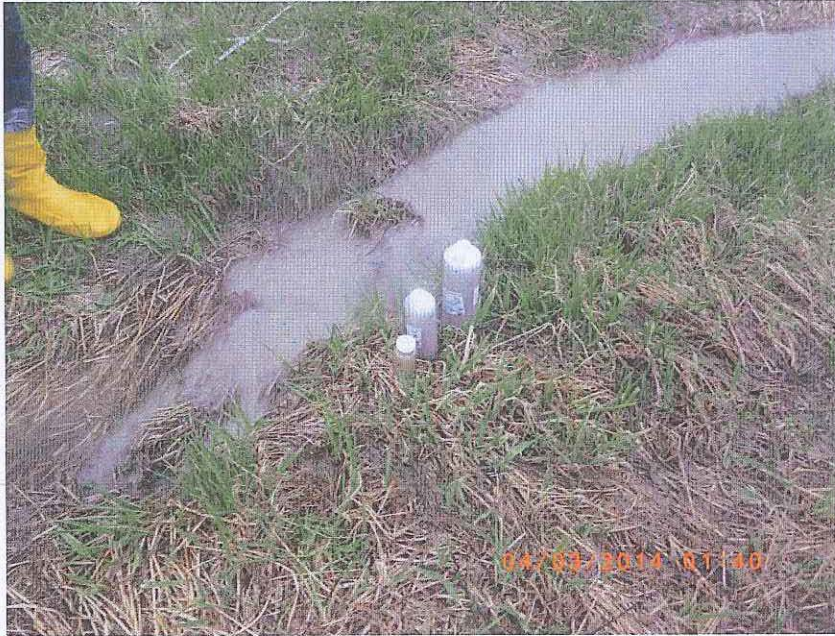
44: IMGP0081

EPA took the fifth sample, S05, named "SW Flow" at 11:05 A.M. from the overland flow pathway that entered the ditch where the black storm water pipe outletted. EPA noted that the overland flow pathway was unbroken and continuous from the west side of the facility.

Description: Sample S05, "SW Flow", was taken at 11:05 A.M. from the overland flow pathway that also entered the ditch by the black pipe.

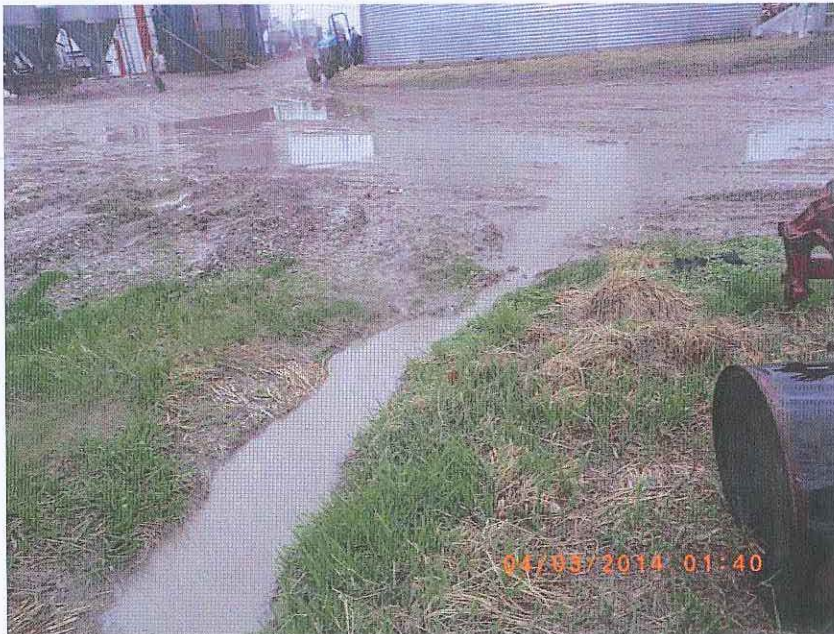
45: IMGP0083

Description: Unbroken path of storm water from the west side of the facility to the ditch.
